UltraAnalytix™ NDT Technique for FRP

Mechanical Integrity and FFS of FRP

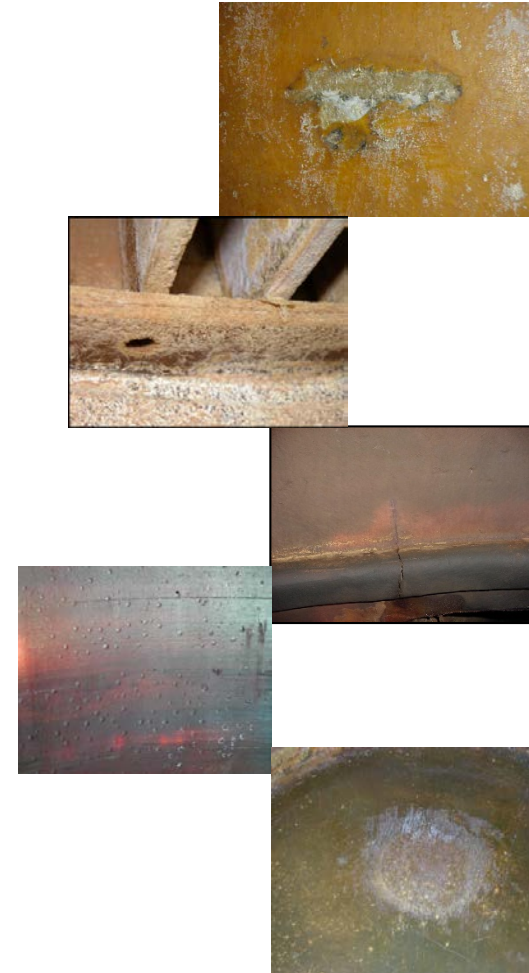
Conventional FRP Inspection

- ❖ Life expectancy and fitness for service is determined by the life of the corrosion barrier
 - Life of the corrosion barrier is determined by visual internal inspection to look for:
 - Cracks, Gouges, Blisters, Surface condition, Abrasion
- ❖ Mechanical integrity is determined from:
 - Acoustic emission
 - Premature end-of-life determination
 - Destructive testing of cutouts
- ❖ *100% INTRUSIVE*

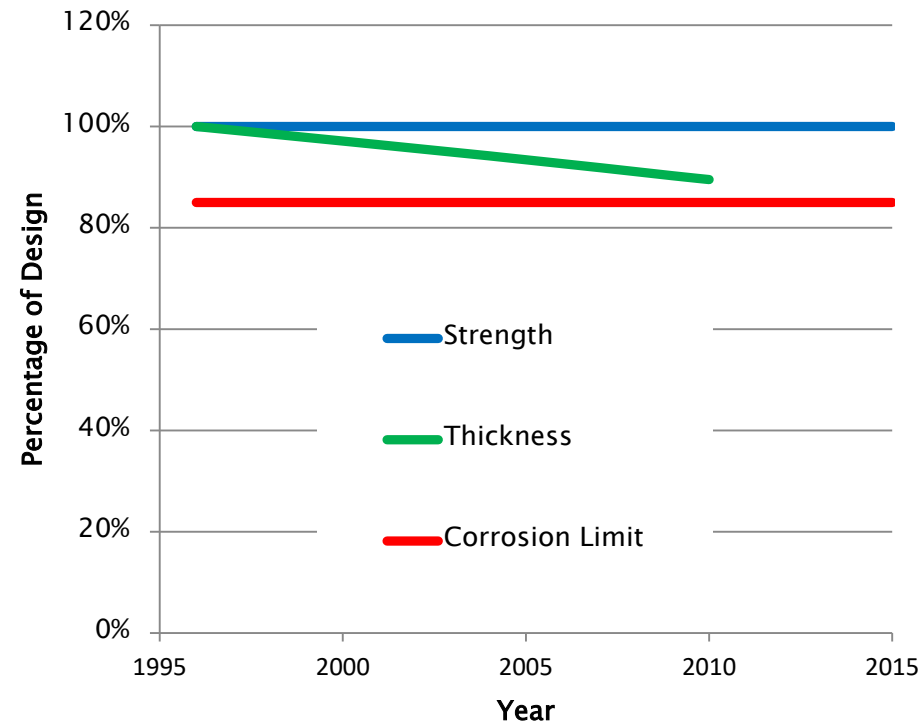
Comparison of Steel to FRP

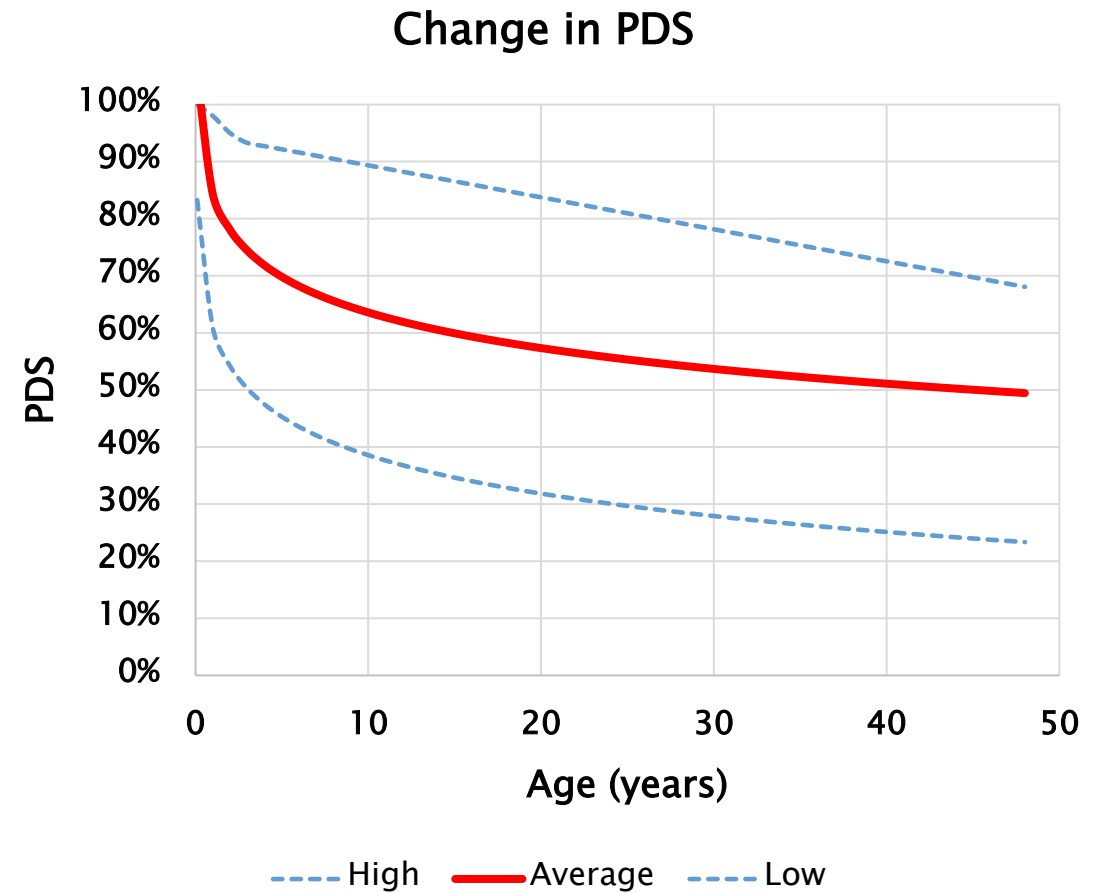
Data from 800 Inspections

- ▶ 800 inspections with multi-year data
- ▶ FRP Age from 0 to 48 years

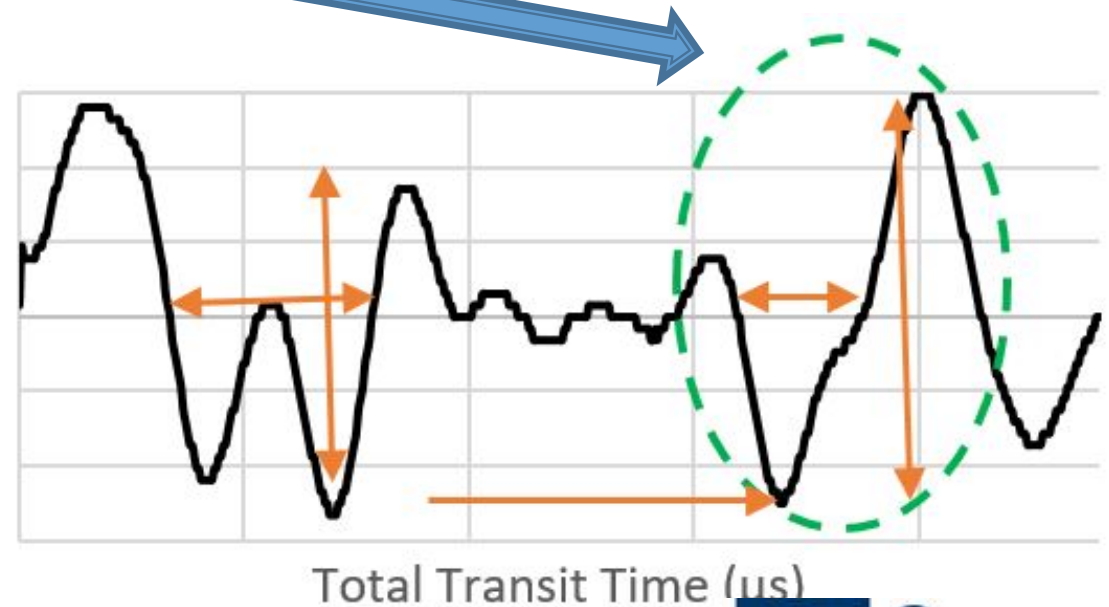
Corrosion Barrier Damage

- ▶ Non-intrusive assessment of:
 - Depth of damage
 - Possible loss of resin Tg
 - Permeation

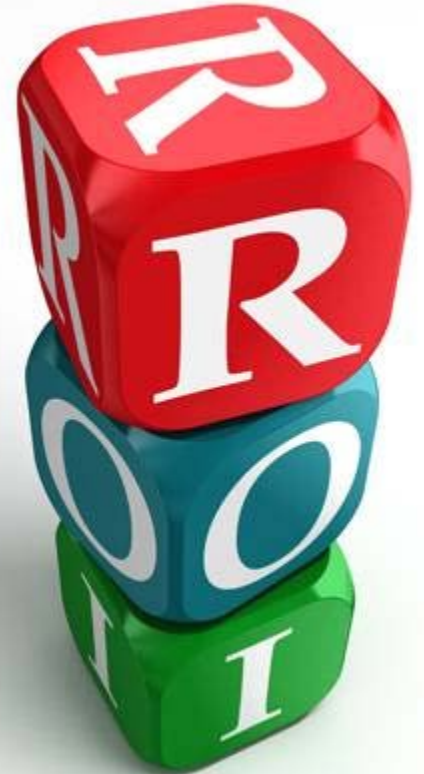
Comparison between UltraAnalytix and other types of evaluation

Method	Equipment operating	Maintains structural Integrity	Internal Structural Changes	Safety Factor Updated	Repeatable	Reliable	Minimizes confined space entry	Inspect Time
UltraAnalytix								15-60 min
Visual Inspection								1-4 hours
Destructive Testing								2 days
Acoustic Emission								2 days+
Digital Radiography								1-4 hours
Thermography								15-60 min
Ultrasonic Thickness Testing								15-60 min
