Inspection guidelines and determination of reasons for failure of flue gas ducts and stacks of fibre-reinforced plastics

Klas Esbo & Love Pallon

KIMAB

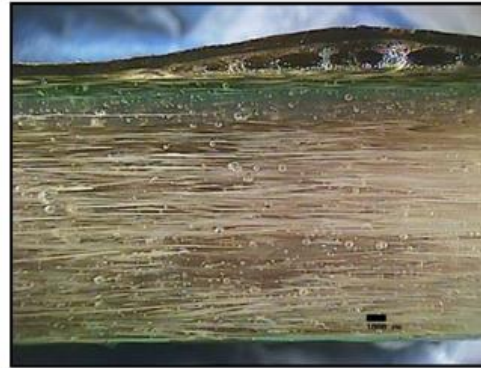
Blisters

- A combination of diffusion and an osmotic pressure
- In general they are superficial and situated close to the surface

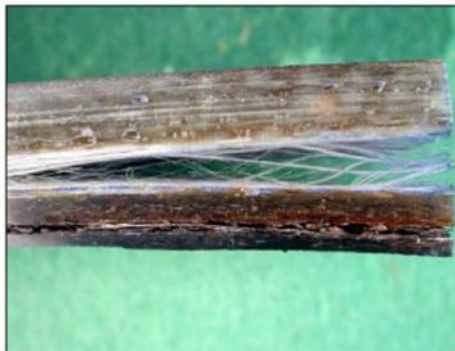
Delaminations

- Often due to thermal stress
- In general more severe than blisters
- Can often be repaired

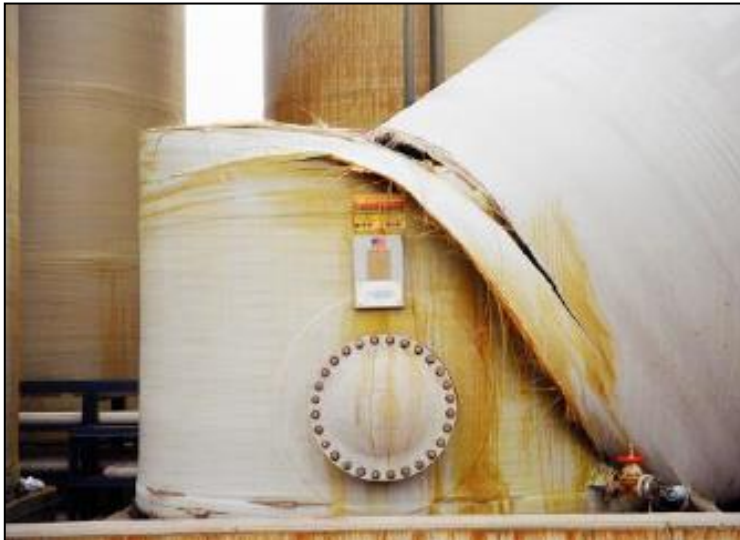
Stress corrosion cracking

- A combination of chemical attack and stress on fibers
- Rapid and dangerous ruptures
- Impact damage can be a starting point for failure

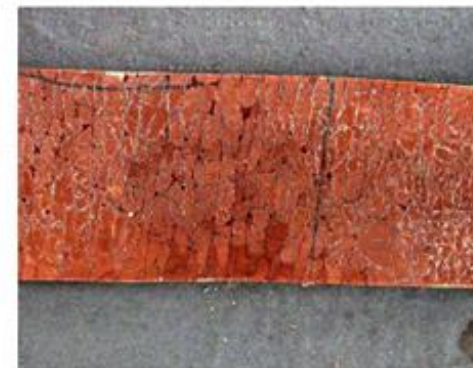
Figure 59. Surface cracking in non-repaired laminate (at a manhole), i.e. 30-year-old laminate, from the bottom part of the scrubber.

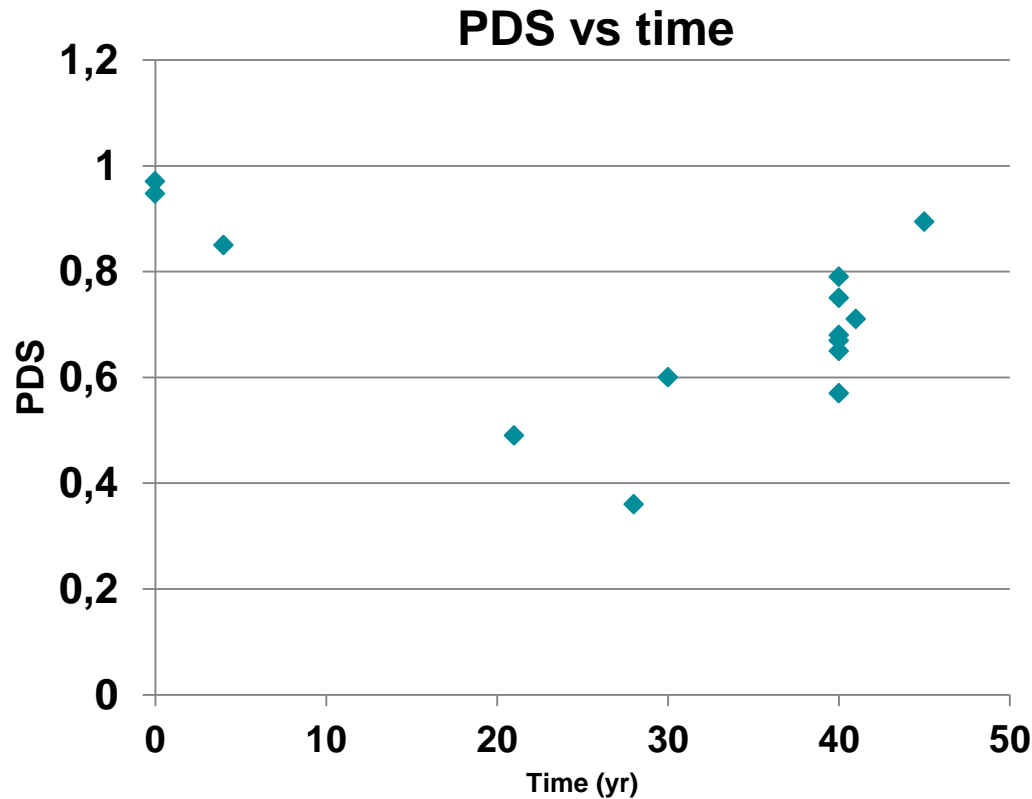
Result

- KIMAB's approach correlates well with the observations from the microscope analysis, and thereby enables remaining service life determinations
- As long as no severe damage modes can be seen, the reduction in E-modulus is limited
