## Defects in glass fibre-reinforced plastics

Examples from industrial practice

Institute for Plastics

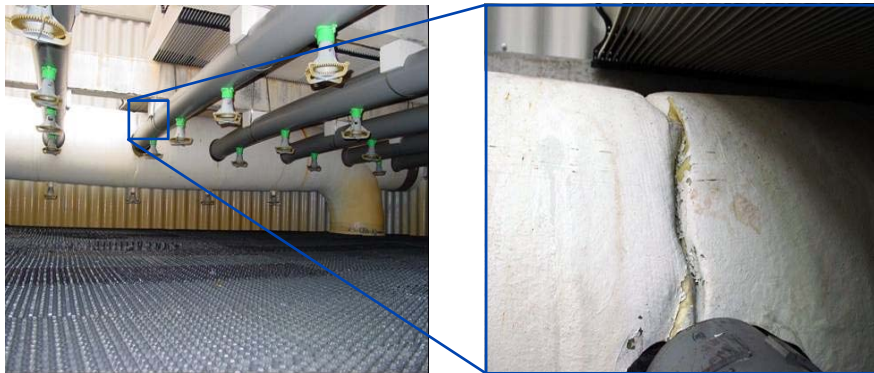
## 2. Examples of defects Breakage/buckling of a pipe

- Determination of wall thickness
- Examination of laminate structure
- Determination of Young's modulus
- Recalculation using finite elements

Non-conforming design – increased compressive stress and pronounced buckling tendency

- Preventive: Examination of design
- Corrective: Pipe replacement

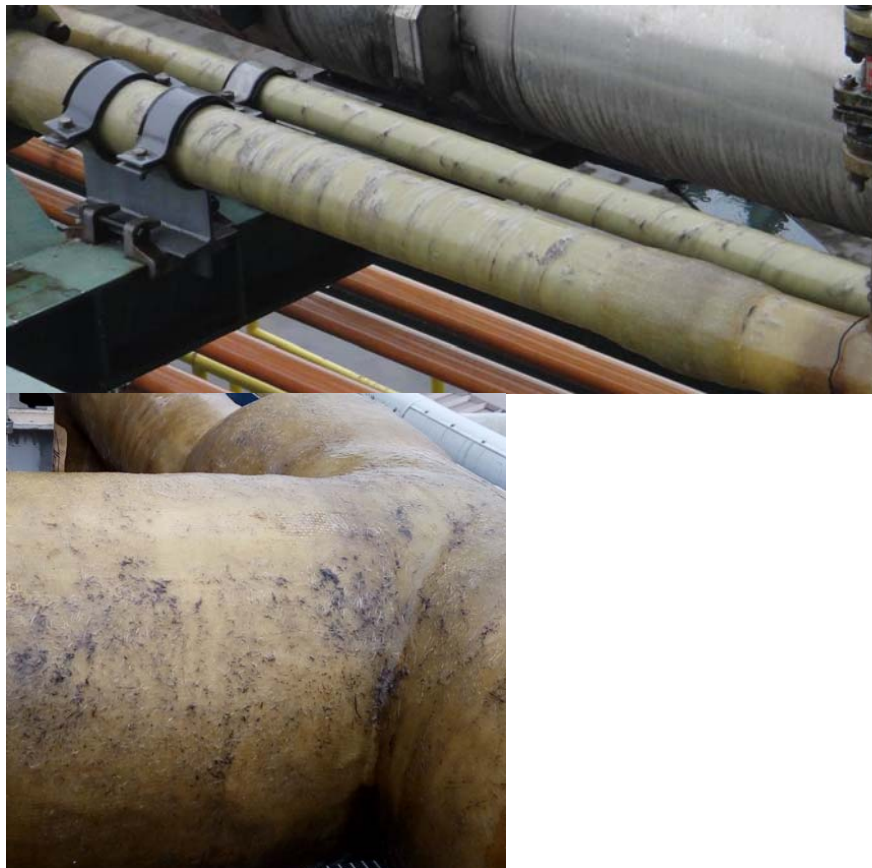
### Pipe leakage

- Visual examination
- Theoretical assessment of resistance to chemicals

Selection of non-conforming materials (not resistant to chemicals)

- Preventive:  
Select material suitable for the application or medium
- Corrective:  
Replace pipe / restrict applicable media

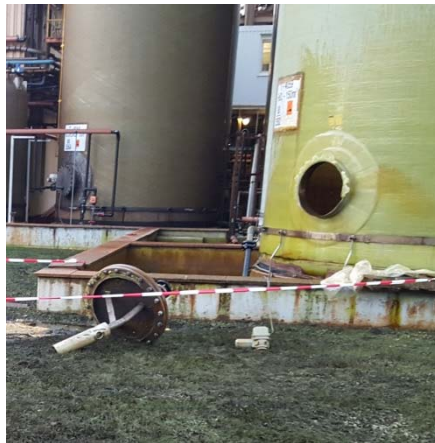
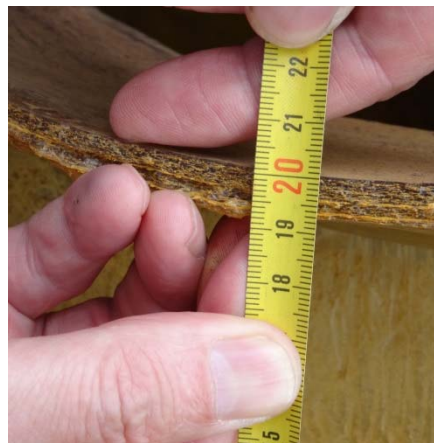
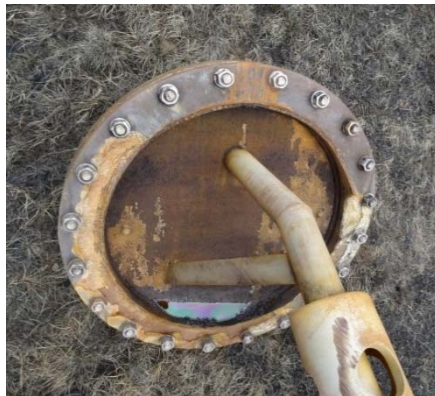
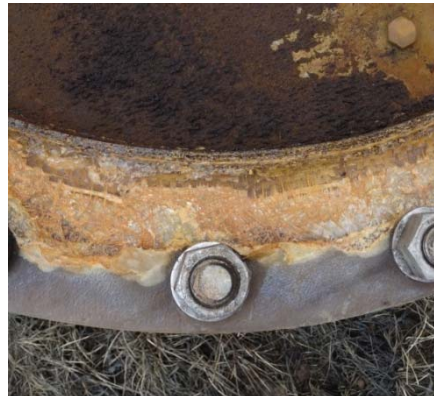
### Nozzle broken off from a tank

- Visual examination including comparison against requirements
- Inspection / re-calculation

Non-conforming dimensioning / design

- Preventive: Examination of design / information
- Corrective: Installation of a new nozzle

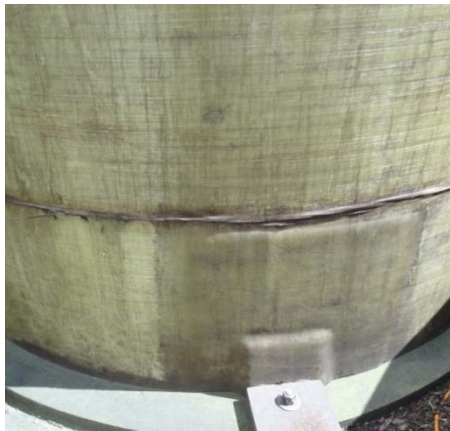
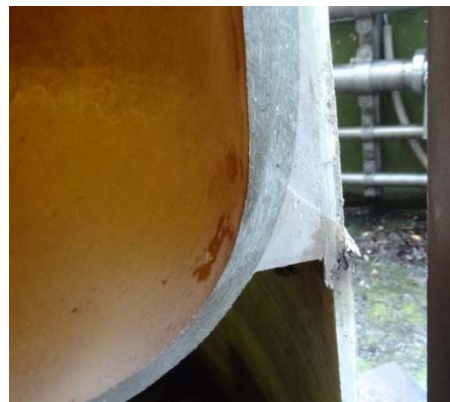
### Breakage of a skirt-mounted tank

- Visual examinations
- Recalculation using finite elements

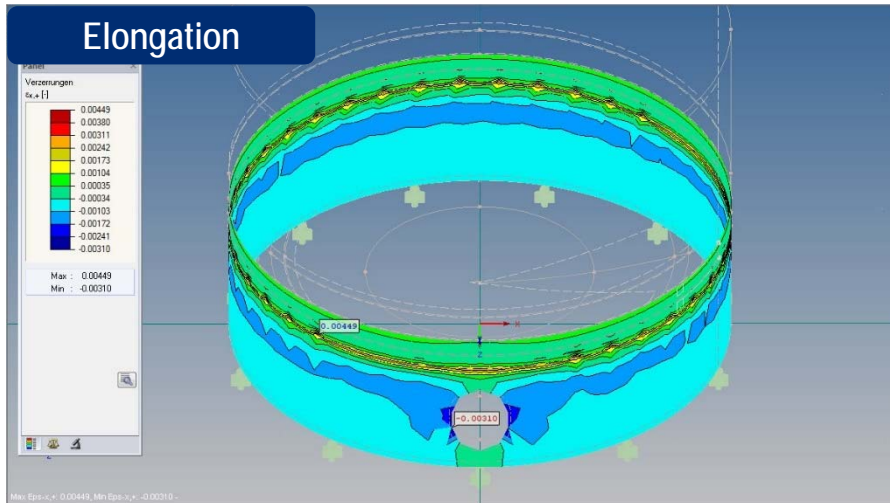
##### Elongation

#### Transition zone with filler

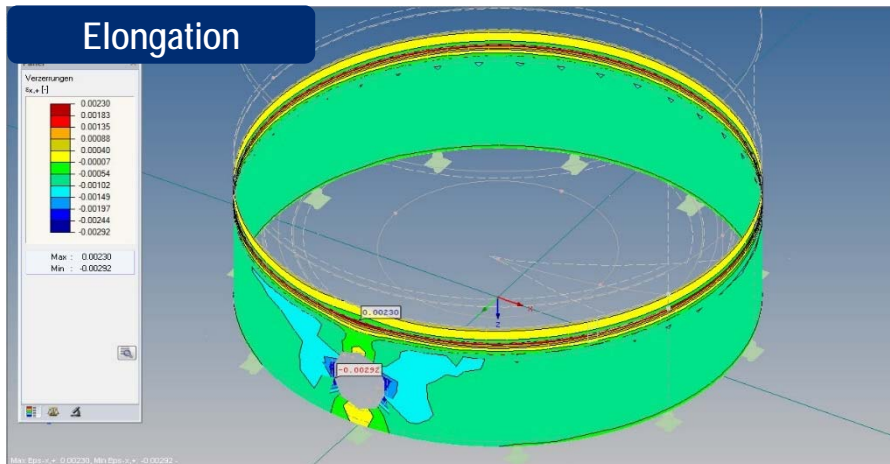
##### Elongation

#### Transition zone without filler

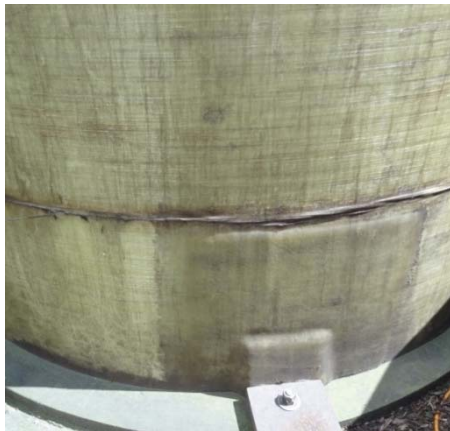
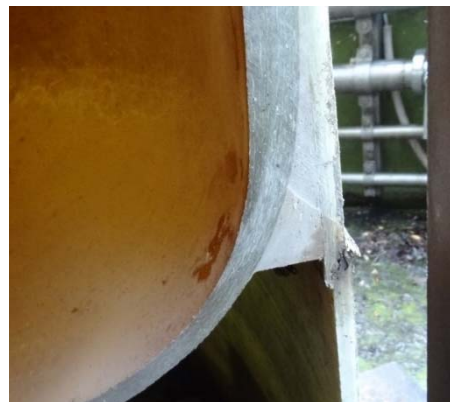
### Breakage of a skirt-mounted tank

- Visual examinations
- Recalculation using finite elements

Non-conformities in design (impermissible outer fibre strain in axial direction – dimensioning)

- Preventive:  
Examination of design / regular checks by officially authorised experts
- Corrective:  
Exterior/interior over-lamination

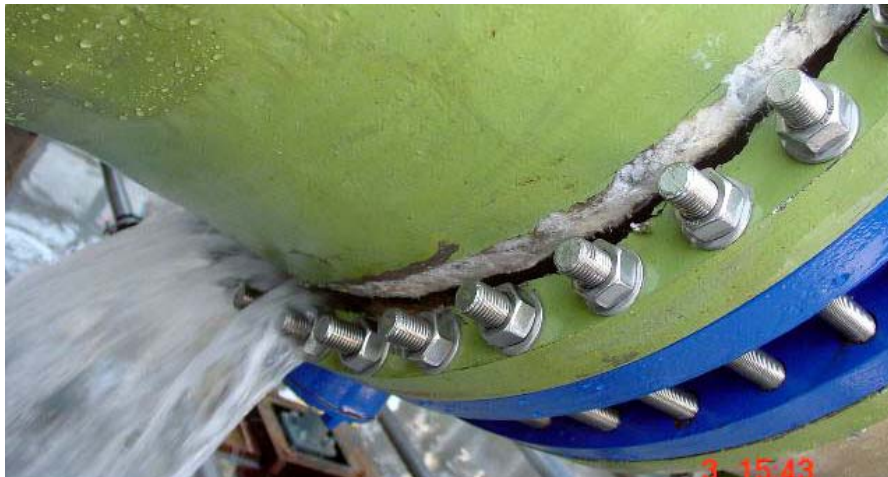
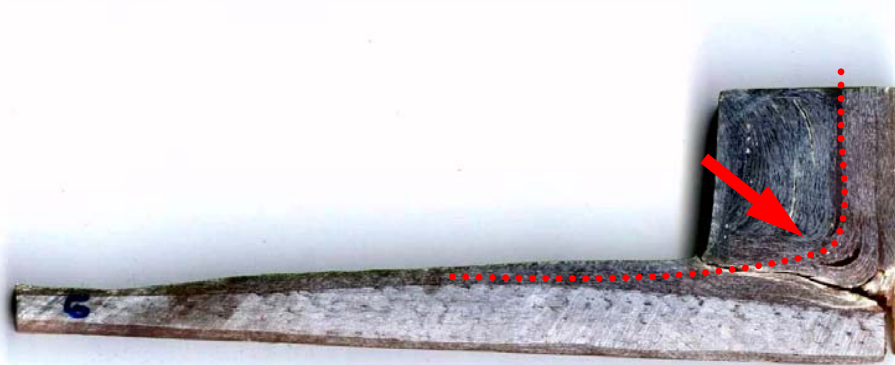
### Defect in flange

- Visual examination (laminate structure)
- Examination of dimensioning
- Analysis of material properties

- Non-conformities in production (reinforcement structure weakened by inadmissible processing)
  - Non-conforming assembly

- Preventive: Compliance with the requirements of the relevant standards/ Personnel qualification
- Corrective: Replacement of pipe/flange

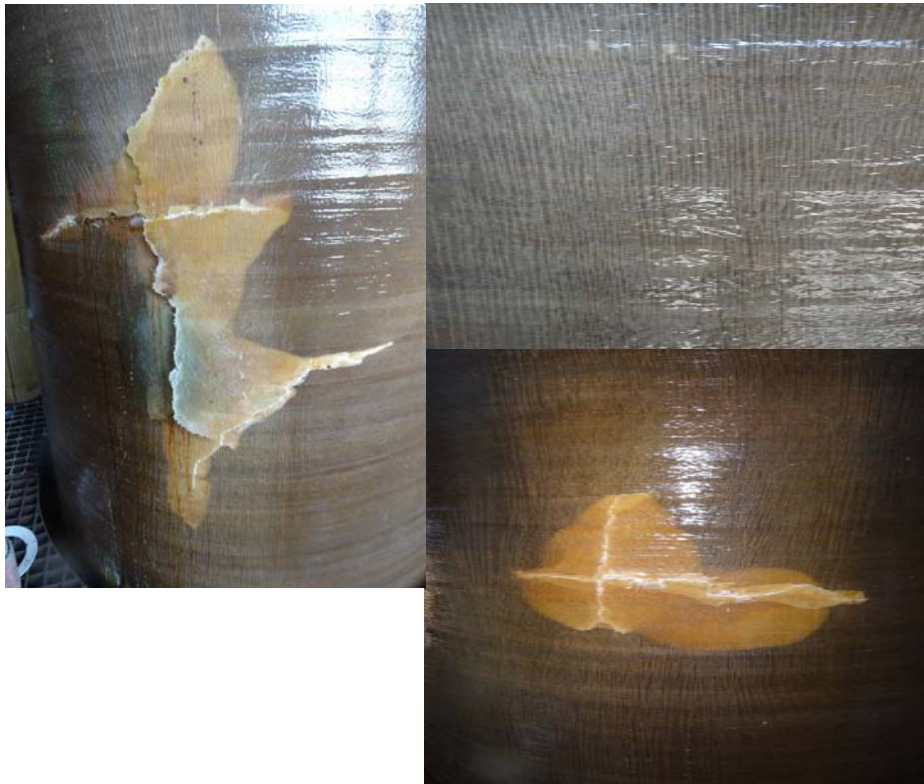
### Defect in a tank

- Visual examination

- Non-conforming design
  - Non-conforming production
  - Non-conforming operating conditions

- Preventive: Surveillance of production, correct design suitable for operating conditions
- Corrective: Manufacturing of a new tank or tank rehabilitation

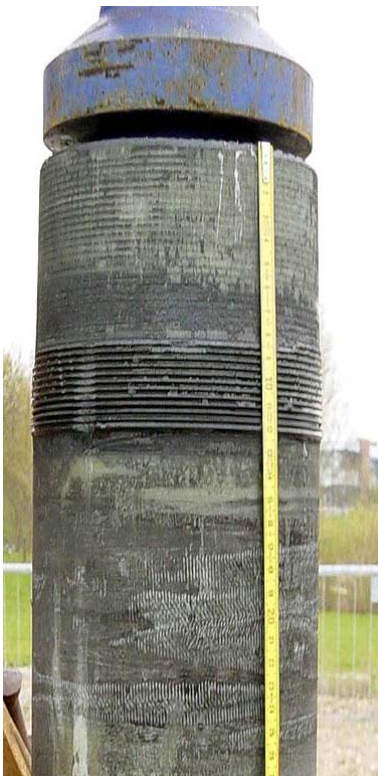
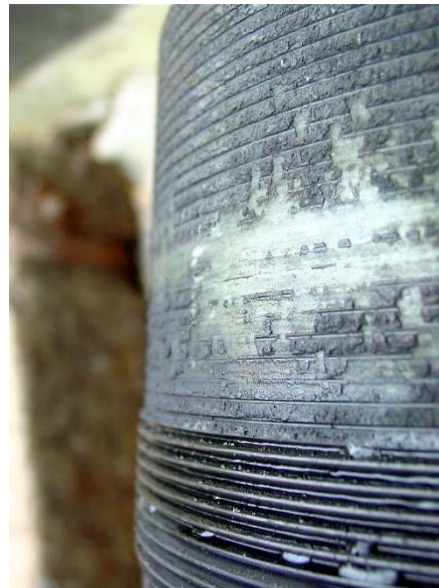
### Shearing of a threaded connection

- Material analysis
- Microscopy
- Checking of the conditions of assembly/use

- 
- 
- Non-conforming material
  - Non-conforming assembly

- Preventive: Surveillance of production/ qualification of assembly staff
- Corrective: Replacement of pipes

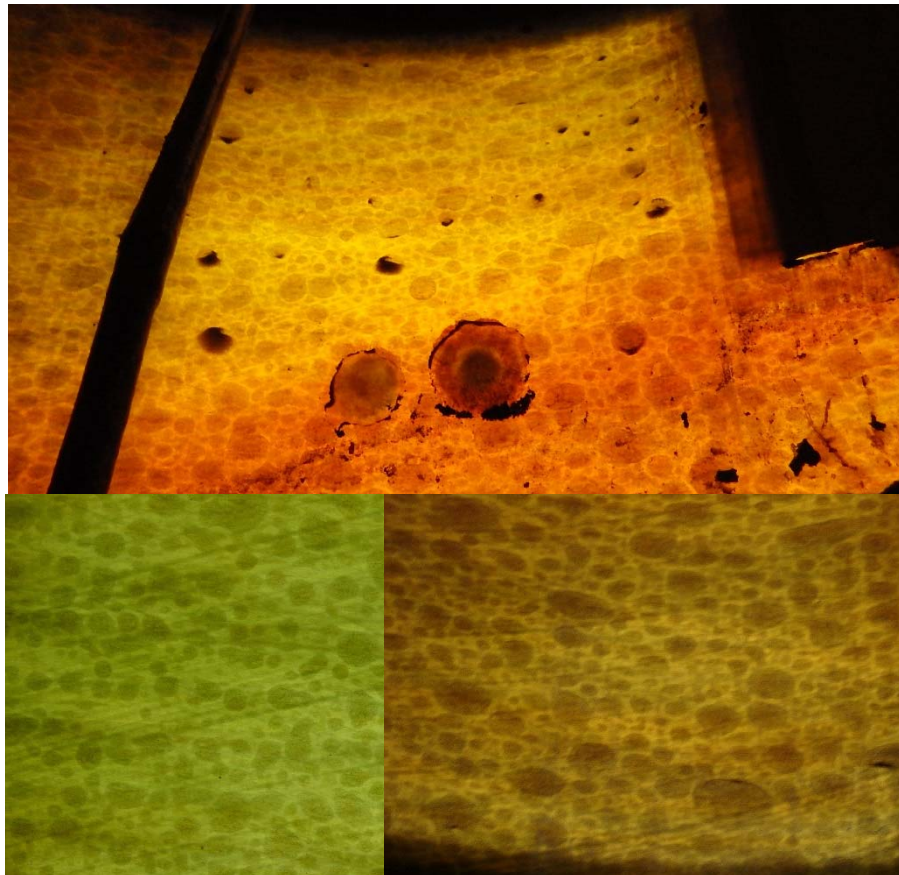
### Osmosis blistering on a tank

- Visual examination (macroscopy / REM)
- Measurement of pH value

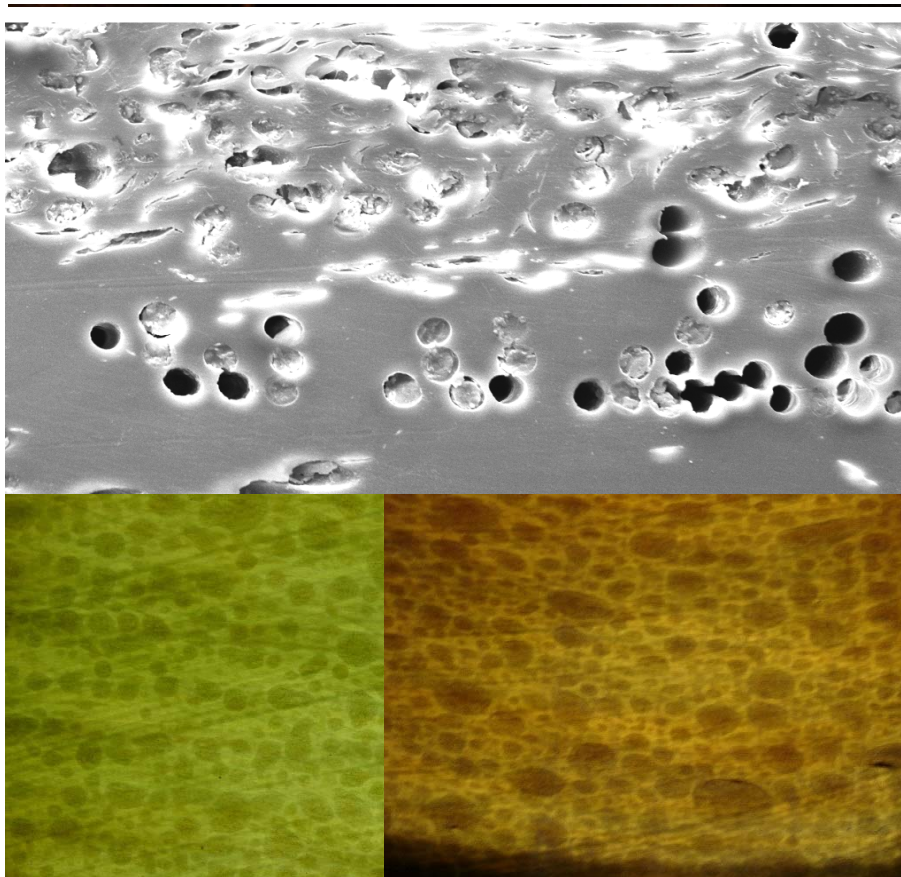
## 2. Examples of defects Osmosis blistering on a tank

- Visual examination (macroscopy / REM)
- Measurement of pH value

Non-conforming design and/or operating conditions

- Preventive: Periodic inspection
- Corrective: Removal of the chemical resistant lining and, if necessary, the load-bearing laminate / Application of new layers

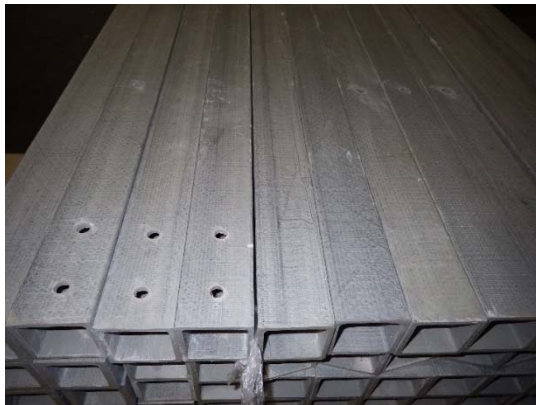
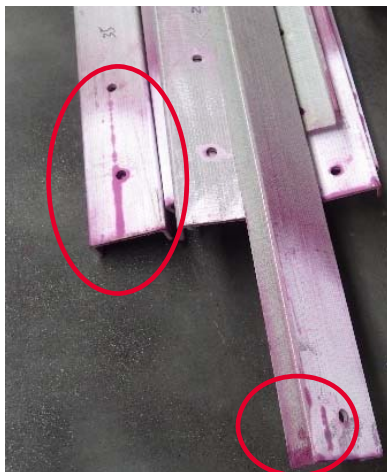
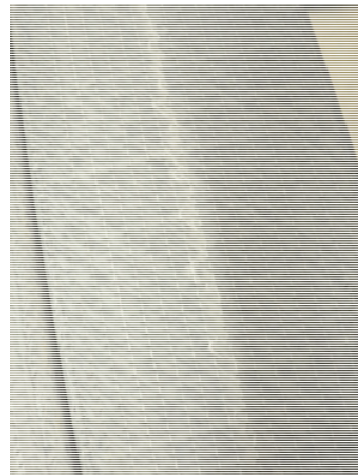
## 2. Examples of defects Dry pultruded profiles

- Glass content / Ashing
- Dye penetrant testing
- Visual examination (microscopy)

Non-conforming production (insufficient impregnation of the glass fibres)

- Preventive: Adjustment of tolerances and requirements
- Corrective: Scrapping and re-production with intensified surveillance

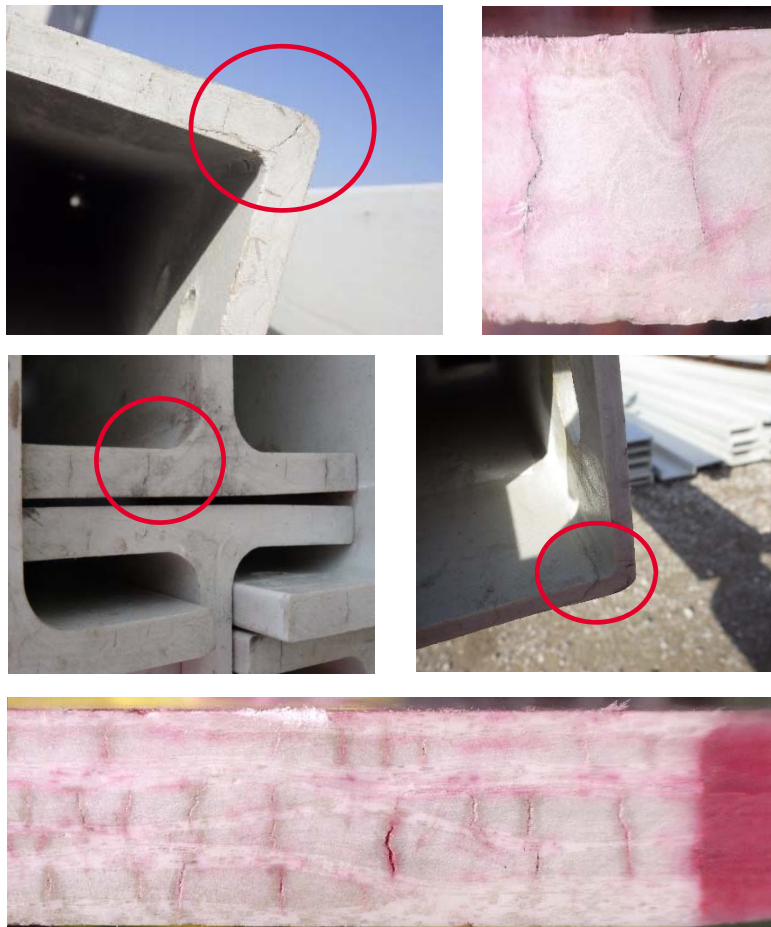
### Shrinkage cracks on pultruded profiles

- Visual examination

- Selection of non-conforming material (resin reactivity)
  - Non-conforming design (layer structure)
  - Non-conforming conditions of production (tempering, run time)

- Preventive: Complete specification
- Corrective: Scrapping and re-production with intensified surveillance
